Kestrel Hood & Exhaust Cleaning

HT-2026-0047

Certificate of Kitchen Exhaust System Cleaning

Maple & Rye Kitchen  
305 Distillery Row

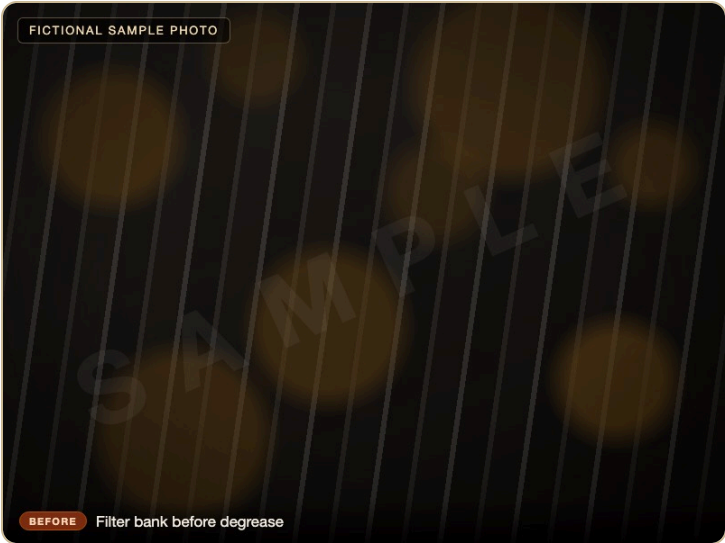
Before: Filter bank before degrease

| Area | Result | Grease depth | Notes |
|---|---|---|---|
| Filters | Cleaned | - | 2 baffle filters replaced |

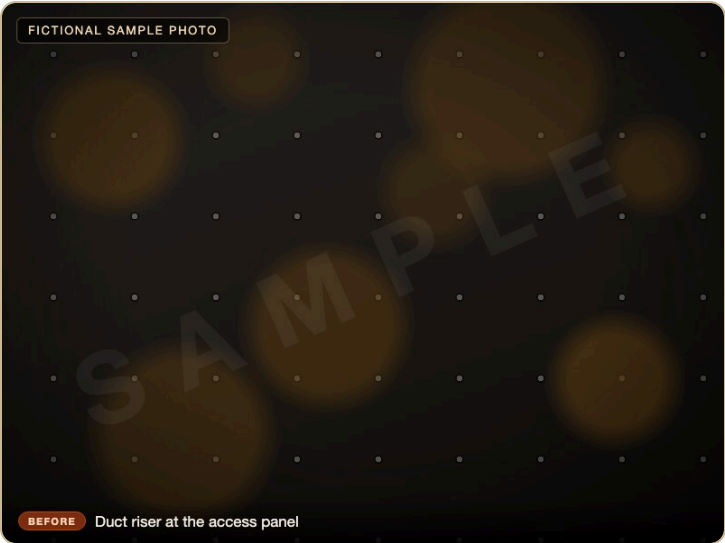
| Area | Result | Grease depth | Notes |
|---|---|---|---|
| Duct, vertical run | Cleaned | 2,300 µm (at cleaning trigger) | - |

Before: Duct riser at the access panel

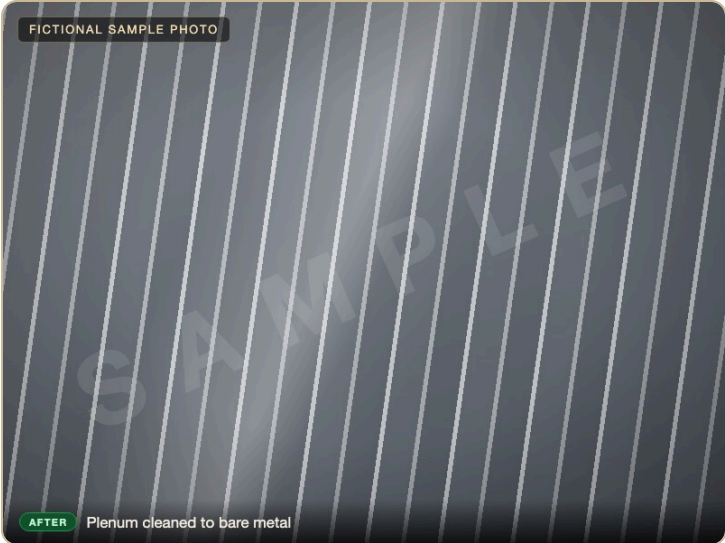
| Area | Result | Grease depth | Notes |
|---|---|---|---|
| Hood interior | Cleaned | 1,800 µm | Polished to bare stainless |

After: Plenum cleaned to bare metal

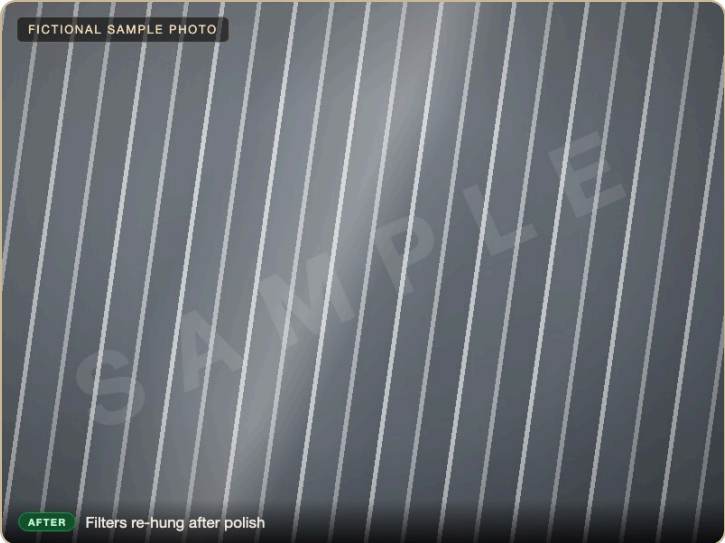
After: Filters re-hung after polish
